**Flood Control Project Maintenance
Levee Inspections**
LMA District Cover Sheet
Spring 2017 Levee Inspection Results

Reclamation District No. 0307 Lisbon

Spring 2017 Levee Inspection Results

| Waterway | | | Bank | Unit Miles |
|--|---|---|---|---|
| Unit No. 01 Sacramento River | | | Right | 6.56 |

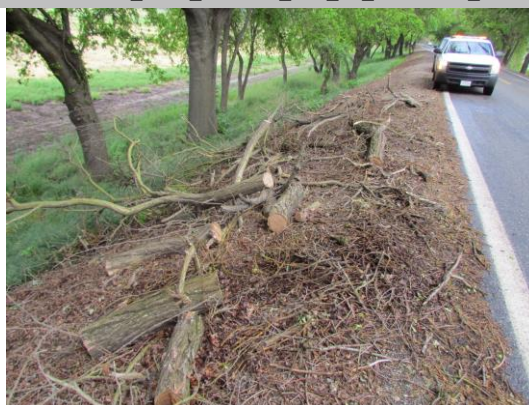
Photo 1 of 1 : SP_2017_RD0307_166_59_20170519_00111.jpg

RD 307 Landside slope looking downstream from levee mile 0.35.

| LM Start | 0.35 | Rating ** | U | Issue No. | 62 |

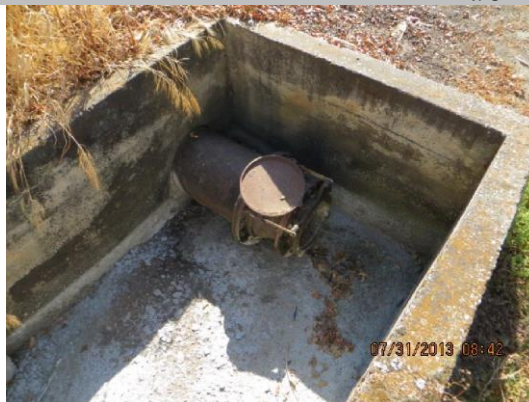
Photo 2 of 3 : UCIP_SP_2017_51632_28732.jpg

UCIP Comments: 12/07/2016 Same as last inspection. The bottom portion of the pipe has several holes through the wall. Recommend owner stop use of crossing. Owner will need to coordinate with CVFPB to comply with Title 23 requirements. (O. Magana - DWR UCIP)07/31/2013 Pipe heavily corroded and will likely need replacement if 15-inch pipe sleeved through it needs replacement. Annular space not grouted between two pipes. (W. Wylie - DWR UCIP) FIELD_STRUCT_DESC: 15-inch steel irrigation pipe through the levee, 16.7 feet below the crown. 15-inch pipe sleeved through an existing 20-inch pipe. 20-inch pipe first recorded in the 1964 USACE O&M Manual. Pump missing from abandoned steel pier located on the waterside (WS) toe. Walkway on the waterside (WS) from shoulder to pier missing or abandoned. Concrete U-shaped outlet with flap gate is located on the landside (LS) toe. Service pole located on the LS slope with anchor. [Additional Reference(s): DWR Levee Log, 1990. USACE Sacramento O&M Manual Unit 114, October 1964, (River Mile 48.53)]. FS Date: 12/7/2016

Pipe at outlet on LS toe.

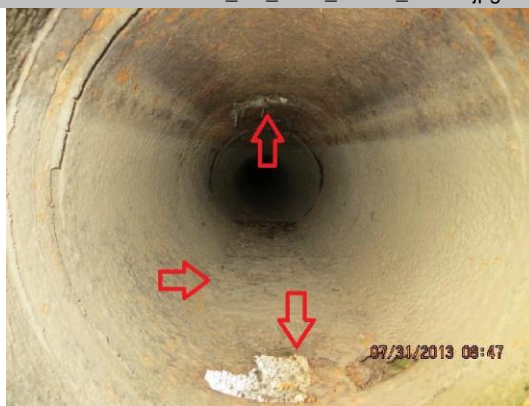
Photo 3 of 3 : UCIP_SP_2017_51632_28731.jpg

| FS_ID:51632 DS_ID:21657 EP_NO: N/A Repair Type: Urgent Crossing Status: Found UCIP Comments: 12/07/2016 Same as last inspection. The bottom portion of the pipe has several holes through the wall. Recommend owner stop use of crossing. Owner will need to coordinate with CVFPB to comply with Title 23 requirements. (O. Magana - DWR UCIP)07/31/2013 Pipe heavily corroded and will likely need replacement if 15-inch pipe sleeved through it needs replacement. Annular space not grouted between two pipes. (W. Wylie - DWR UCIP) FIELD_STRUCT_DESC: 15-inch steel irrigation pipe through the levee, 16.7 feet below the crown. 15-inch pipe sleeved through an existing 20-inch pipe. 20-inch pipe first recorded in the 1964 USACE O&M Manual. Pump missing from abandoned steel pier located on the waterside (WS) toe. Walkway on the waterside (WS) from shoulder to pier missing or abandoned. Concrete U-shaped outlet with flap gate is located on the landside (LS) toe. Service pole located on the LS slope with anchor. [Additional Reference(s): DWR Levee Log, 1990. USACE Sacramento O&M Manual Unit 114, October 1964, (River Mile 48.53)]. FS Date: 12/7/2016 | | | | | |

Holes and corrosion shown inside 15-inch pipe sleeved through this pipe.

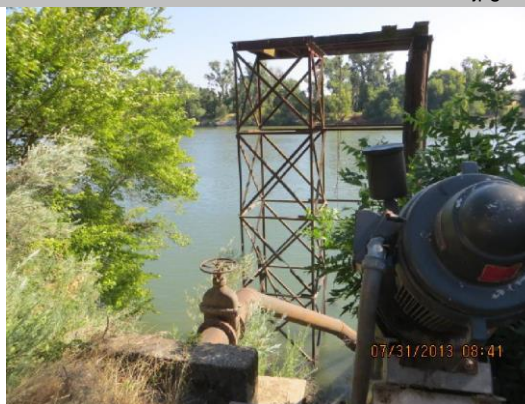
Photo 2 of 3 : UCIP_SP_2017_51444_28721.jpg

| FS_ID:51444 DS_ID:21656 EP_NO: N/A Repair Type: Urgent Crossing Status: Found UCIP Comments: 12/07/2016 Same as last inspection. The bottom portion of the pipe has several holes through the wall. Recommend owner stop use of crossing. Owner will need to coordinate with CVFPB to comply with Title 23 requirements. (O. Magana - DWR UCIP)07/31/2013 Pipe heavily corroded at outlet on LS toe. Holes on bottom of pipe at outlet and internal circumference shows heavy exfoliation. Pipe failing internally. Recommend replacement or video inspection before continuing use. (W. Wylie - DWR UCIP) FIELD_STRUCT_DESC: *DUPLICATE--DELETE* 1 of 2: 15-inch steel irrigation pipe sleeved through 21-inch steel conduit, through the levee 16.7 feet below crown. Slant pump, gate valve, concrete headwall, electrical control pane, and abandoned pier on WS slope. Concrete U-shaped outlet with flap gate on LS toe. Service pole on the landward slope with anchor. [Additional Reference(s): DWR Levee Log, 1990]. FS Date: 12/7/2016 | | | | | |

Pipe, gate valve, pump, and abandoned metal pier on WS slope.

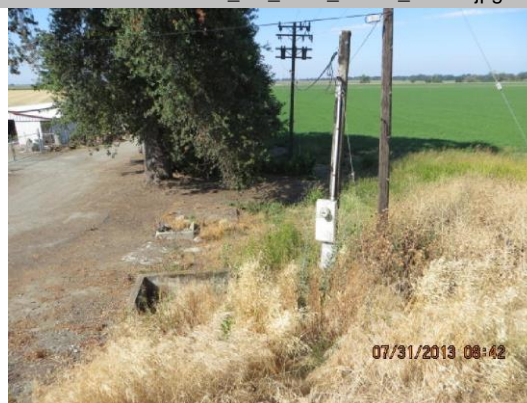
Photo 3 of 3 : UCIP_SP_2017_51444_28720.jpg

| FS_ID:51444 DS_ID:21656 EP_NO: N/A Repair Type: Urgent Crossing Status: Found UCIP Comments: 12/07/2016 Same as last inspection. The bottom portion of the pipe has several holes through the wall. Recommend owner stop use of crossing. Owner will need to coordinate with CVFPB to comply with Title 23 requirements. (O. Magana - DWR UCIP)07/31/2013 Pipe heavily corroded at outlet on LS toe. Holes on bottom of pipe at outlet and internal circumference shows heavy exfoliation. Pipe failing internally. Recommend replacement or video inspection before continuing use. (W. Wylie - DWR UCIP) FIELD_STRUCT_DESC: *DUPLICATE--DELETE* 1 of 2: 15-inch steel irrigation pipe sleeved through 21-inch steel conduit, through the levee 16.7 feet below crown. Slant pump, gate valve, concrete headwall, electrical control pane, and abandoned pier on WS slope. Concrete U-shaped outlet with flap gate on LS toe. Service pole on the landward slope with anchor. [Additional Reference(s): DWR Levee Log, 1990]. FS Date: 12/7/2016 | | | | | | |

Concrete U-shaped outlet, JP, and meter on LS toe.

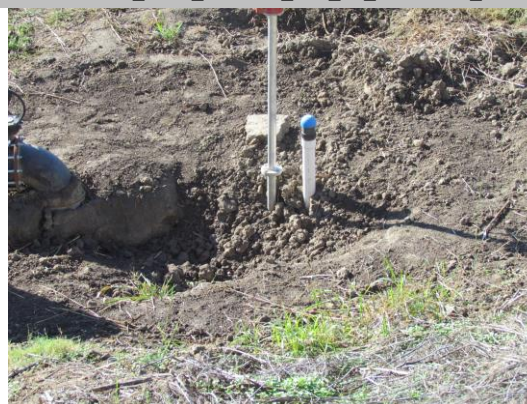
Photo 1 of 2 : SP_2017_RD0307_166_58_20170404_00015.jpg

| The sand filter and concrete foundation is under new ownership and they are working with CVFPB for a permit to retain this pending Encroachment. | | | | | |

New pipe added to the filtration system installed, no permit issued for encroachment.

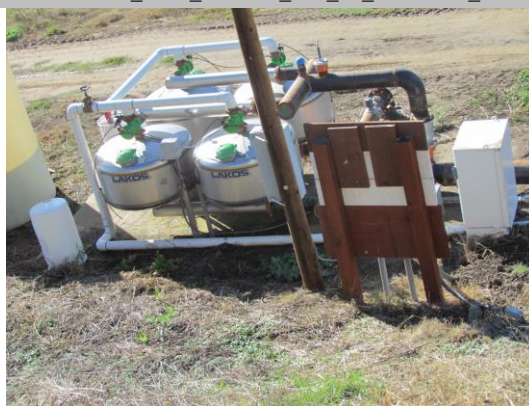
Photo 2 of 2 : SP_2017_RD0307_166_58_20170404_00016.jpg

| The sand filter and concrete foundation is under new ownership and they are working with CVFPB for a permit to retain this pending Encroachment. | | | | | | |

Sand filter and new power pole, panel box, electrical conduit and tanks on easement. Levee mile 0.58.

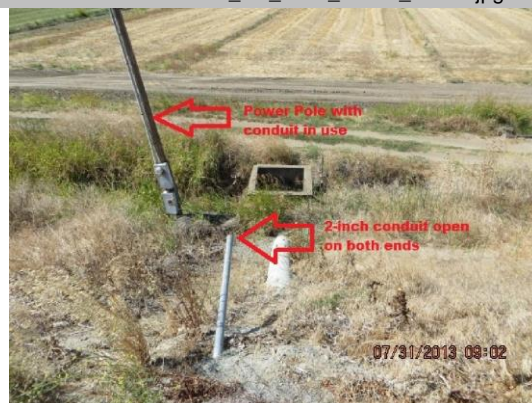
Photo 1 of 3 : UCIP_SP_2017_17103_29202.jpg

| FS_ID:17103 DS_ID:24014 EP_NO: 18229 Repair Type: Non-Urgent Crossing Status: Found UCIP Comments: Pipe open on both ends. Need to install caps. FIELD_STRUCT_DESC: 2 of 2: 2-inch galvanized iron pipe through the levee 2.0 feet below the crown (Permit No. 18229, 2007). FS Date: 7/31/2013 | | | | | |

Conduit visible 2-feet below the crown on the LS shoulder.

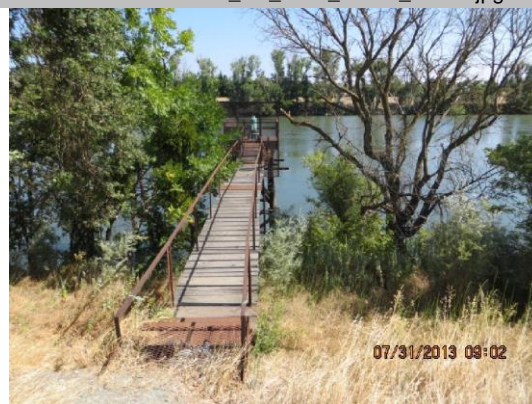
Photo 2 of 3 : UCIP_SP_2017_17103_29201.jpg

Conduit visible under first step of walkway to pump on WS shoulder.

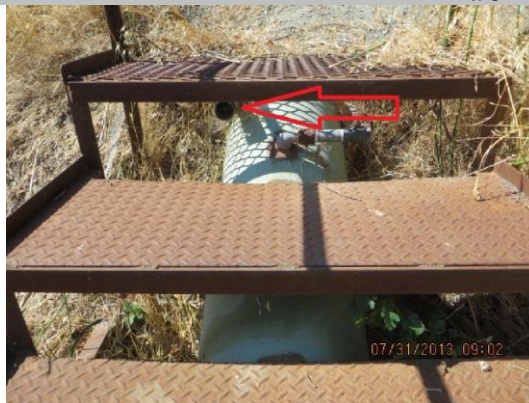
Photo 3 of 3 : UCIP_SP_2017_17103_29200.jpg

| FS_ID:17103 DS_ID:24014 EP_NO: 18229 Repair Type: Non-Urgent Crossing Status: Found UCIP Comments: Pipe open on both ends. Need to install caps. FIELD_STRUCT_DESC: 2 of 2: 2-inch galvanized iron pipe through the levee 2.0 feet below the crown (Permit No. 18229, 2007). FS Date: 7/31/2013 | | | | | | |

Conduit visible under first step of walkway to pump on WS shoulder.

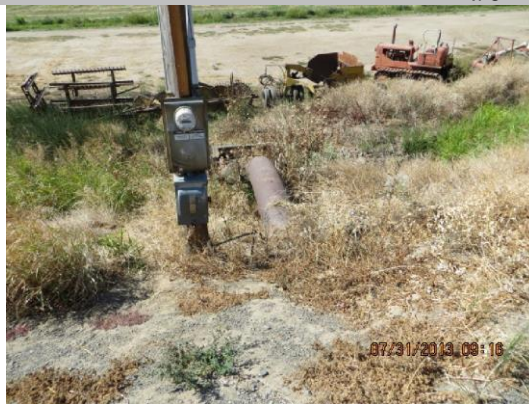
Photo 1 of 3 : UCIP_SP_2017_16764_28764.jpg

| UCIP Comments: Pipe rusted through at outlet on LS of shutoff valve. | | | | | |
| This may be good indicator or corrosion throughout pipe. This is a good | | | | | |

Pipe and JP/meter on LS slope.

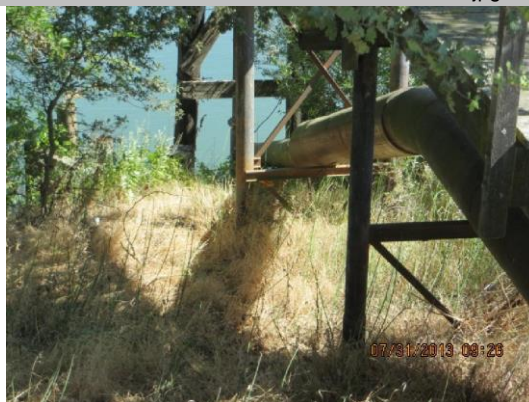
Photo 3 of 3 : UCIP_SP_2017_16764_28762.jpg

| UCIP Comments: Pipe rusted through at outlet on LS of shutoff valve. | | | | | | |
| This may be good indicator or corrosion throughout pipe. This is a good | | | | | | |

Pipe visible under wooden walkway on WS slope.

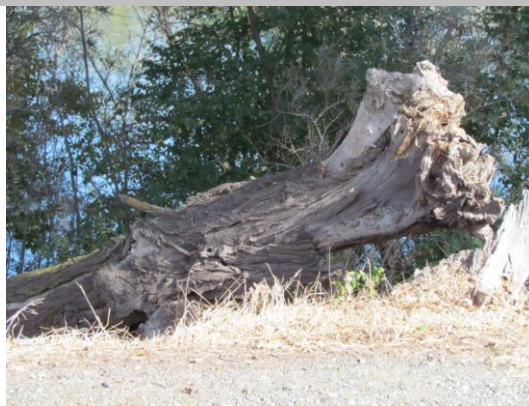
Photo 1 of 1 : SP_2017_RD0307_166_9_20170404_00006.jpg

This tree needs to be removed from the waterside slope. No change 4-17.

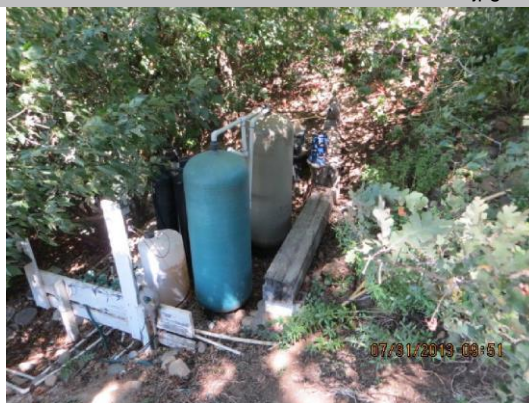
Photo 1 of 3 : UCIP_SP_2017_17106_29210.jpg

| FS_ID:17106 DS_ID:24016 EP_NO: N/A Repair Type: Non-Urgent Crossing Status: Found UCIP Comments: No permit identified for this crossing. FIELD_STRUCT_DESC: 1 of 2: 1.5-inch PVC pipe through the levee 2-feet below the crown. Metal walkway/pier on WS slope. Possible pump, Filter, and tanks on LS slope. FS Date: 7/31/2013 | | | | | |

Possible pump and filter plant on LS slope.

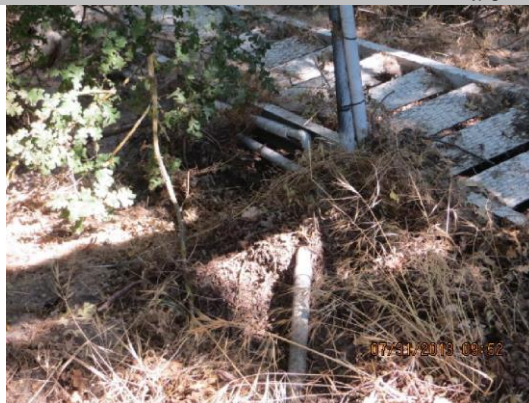
Photo 2 of 3 : UCIP_SP_2017_17106_29209.jpg

| FS_ID:17106 DS_ID:24016 EP_NO: N/A Repair Type: Non-Urgent Crossing Status: Found UCIP Comments: No permit identified for this crossing. FIELD_STRUCT_DESC: 1 of 2: 1.5-inch PVC pipe through the levee 2-feet below the crown. Metal walkway/pier on WS slope. Possible pump, Filter, and tanks on LS slope. FS Date: 7/31/2013 | | | | | |

Pipes visible on WS shoulder at metal ramp.

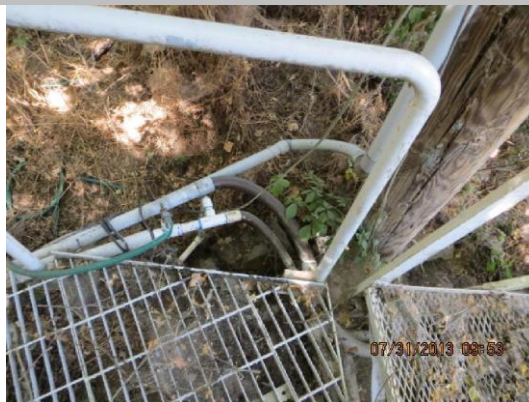
Photo 3 of 3 : UCIP_SP_2017_17106_29208.jpg

Pipes visible under metal ramp on WS slope.

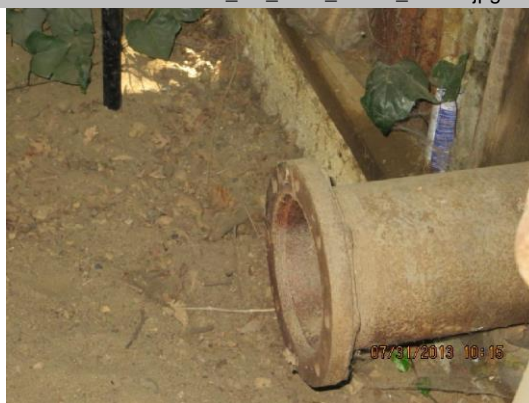
Photo 1 of 2 : UCIP_SP_2017_16805_28806.jpg

| FS_ID:16805 DS_ID:21663 EP_NO: 8016 Repair Type: Non-Urgent Crossing Status: Indicator Found UCIP Comments: Needs to be abandoned properly. FIELD_STRUCT_DESC: *ABANDONED* 8-inch iron pipe through the levee 15.7 feet below the crown. No connection in pump house on the LS toe, but 8-inch outlet pipe remains at connection from pumphouse to concrete standpipe. (Permit No. 8016, 1972). Pipe capped at both ends according to Permit No. 18209 for replacement pipe. Originally included in the 1959 O&M manual. FS Date: 7/31/2013 | | | | | |

Remnants of abandoned pipe visible in pumphouse on LS toe.

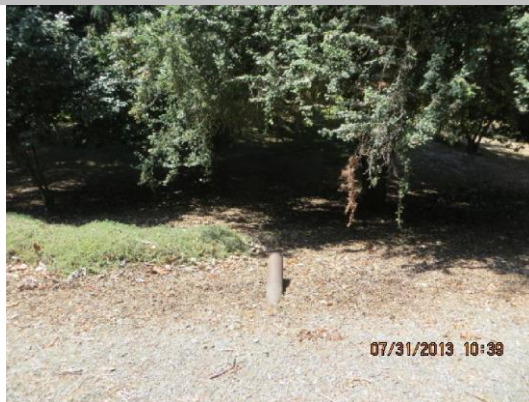
Photo 2 of 3 : UCIP_SP_2017_22709_38411.jpg

FS_ID:22709
DS_ID:21665
EP_NO: N/A
Repair Type: Non-Urgent
Crossing Status: Found
UCIP Comments: Pipe abandoned and should be done so properly.
FIELD_STRUCT_DESC: 5-inch steel irrigation pipe through the levee 2.0-feet below the crown. Pipe open on both ends. Originally included in the 1959 O&M manual.
FS Date: 7/31/2013

Pipe visible on LS shoulder.

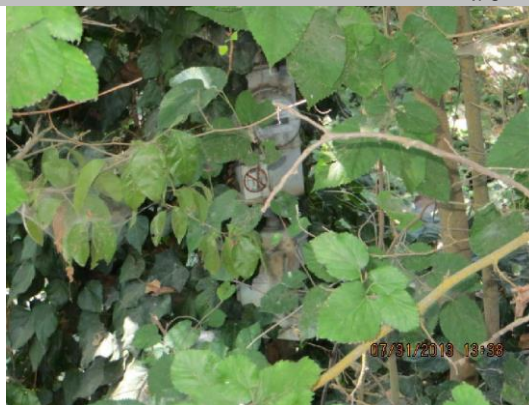
Photo 3 of 3 : UCIP_SP_2017_16924_28980.jpg

Meter on JP at LS toe covered with vegetation/IVY.

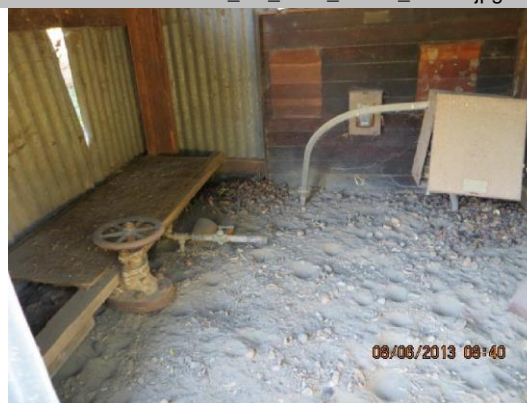
Photo 3 of 3 : UCIP_SP_2017_51446_29259.jpg

Gate valve in pumphouse on LS toe. pumphouse filled with soil.

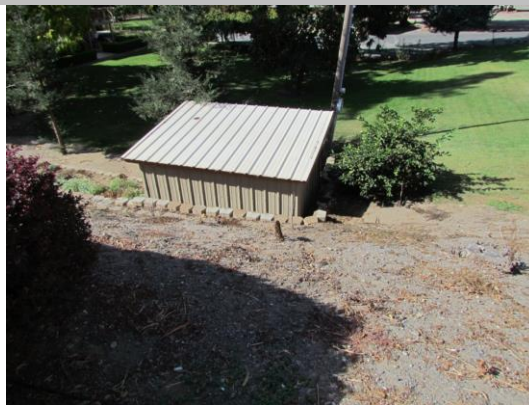
Photo 1 of 1 : SP_2017_RD0307_166_26_20170404_00008.jpg

This pump house was built without CVFPB Permit.

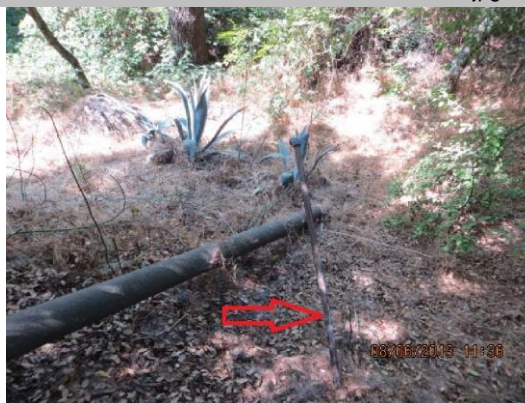
Photo 1 of 1 : UCIP_SP_2017_22672_38296.jpg

Abandoned electrical conduit next to pipe on LS slope.

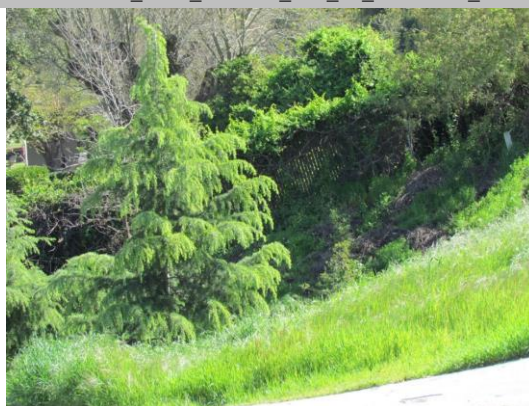
Photo 2 of 5 : SP_2017_RD0307_166_28_20170404_00011.jpg

Looking upstream landside slope and toe trees planted on the levee section.

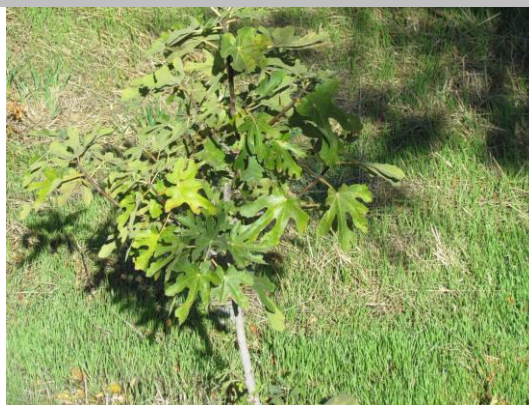
Photo 4 of 5 : SP_2017_RD0307_166_28_20170404_00013.jpg

RD 307 Looking downstream levee slope and toe are young unauthorized fig trees.

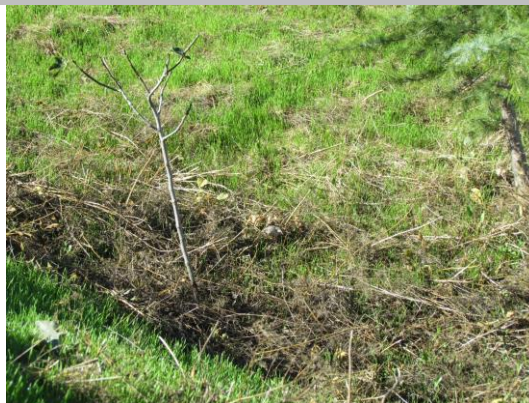
Photo 5 of 5 : SP_2017_RD0307_166_28_20170404_00014.jpg

RD 307 Looking downstream from the levee slope and toe are more young unauthorized fig trees.

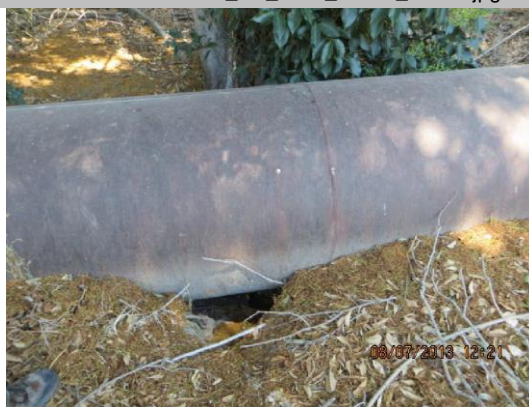
Photo 2 of 3 : UCIP_SP_2017_17404_29503.jpg

Animal activity/burrows under pipe on LS at various locations.
